UTAH STATE CAPITOL ARCHITECTURE: EXTERIOR SURVEY REPORT

ELEVATION LOCATION: WEST ELEVATION

Survey Date: 4/24/00

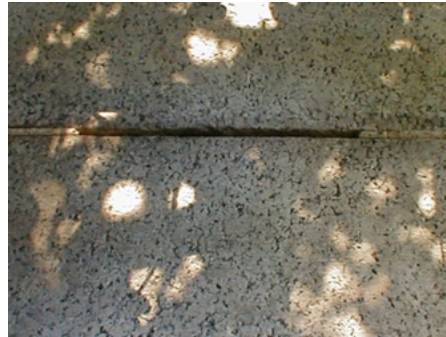
Description: Foundation stone

Location: base

Grid: B/S 74; B/N 30

Condition: J

Mortar joint with missing or loose mortar

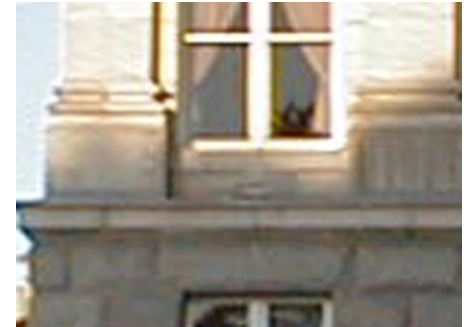
Description: Foundation stone

Grid: B/S 74

Condition: CR

Cracked element

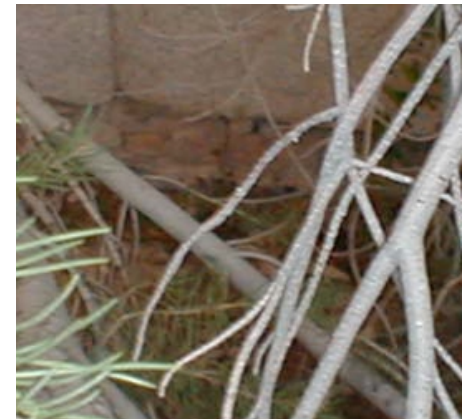
Description: Foundation stone

Grid: B/N 60

Condition: J

Mortar joint with missing or loose mortar

Comments: bricks exposed below EX-1.

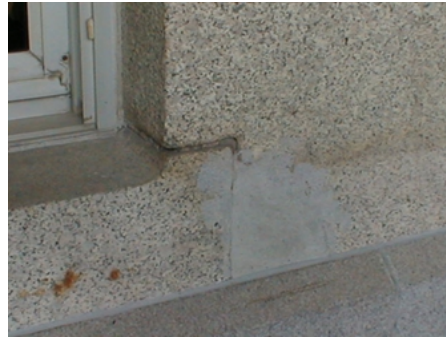
Code: EX-001**Description:** Foundation stone**Location:****Grid:** B/ N 110**Condition:** BR, PATBroken element, poor quality
patching**Comments:**

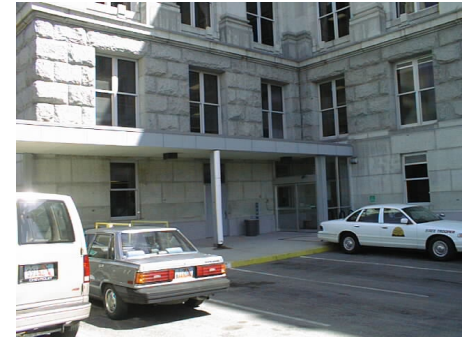
**Code:** EX-001**Description:** Foundation stone**Location:****Grid:** B/N 110**Condition:** NONon-original, incompatible but
essential elements**Comments:** covered walkway, metal door--PH
25.

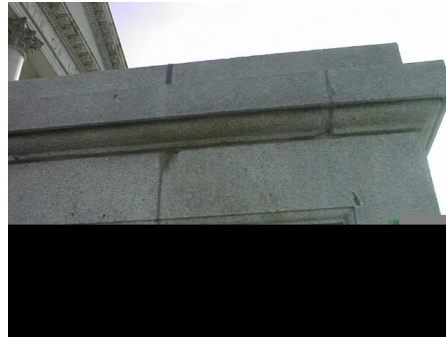
**Code:** EX-001**Description:** Foundation stone**Location:** at front steps**Grid:** B/S 1**Condition:** BR, CR, INT, STBroken, cracked, stained element,
and intrusive element**Comments:** Int--plastic anchor; St--metal
protrusion; Rusting

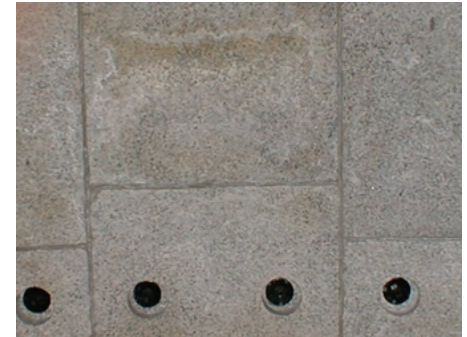
**Code:** EX-001**Description:** Foundation stone**Location:** arch underneath stairs, above gate**Grid:** B/S 1**Condition:** STSignificant Staining; may
indicate rusted connector**Comments:** efflorescence

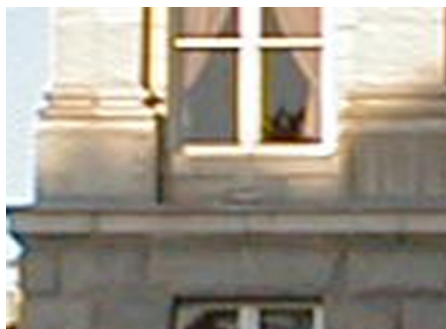
Code: EX-002**Description:** Basement wall stone*Location:**Grid:**Condition:* J, STMortar joint damage and
significant staining*Comments:* around window

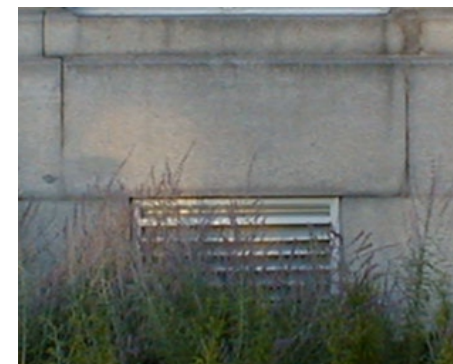
**Code: EX-002****Description:** Basement wall stone*Location:**Grid:* B/S 35*Condition:* CR, J, STCracking, mortar joint damage,
and staining*Comments:* 2 alum vents--PH 28 W/ ST &
rough stone; NO ; plastic
anchors--PH 29/ NT

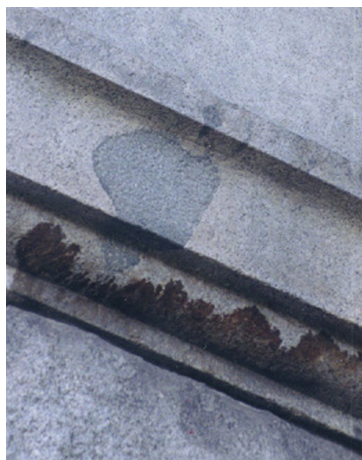
**Code: EX-003****Description:** Lower belt course*Location:**Grid:**Condition:* STSignificant Staining; may
indicate rusted connector*Comments:* almost continuous

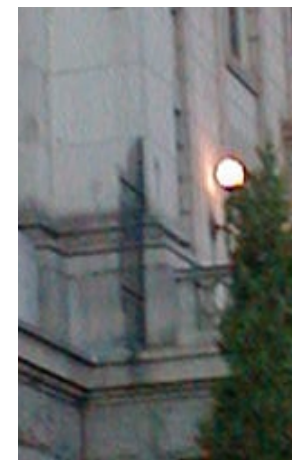
**Code: EX-005****Description:** Pilaster base*Location:**Grid:* C/S 74*Condition:* NONon-original, incompatible but
essential elements*Comments:* metal restraint - bent, old holes,
metal remains

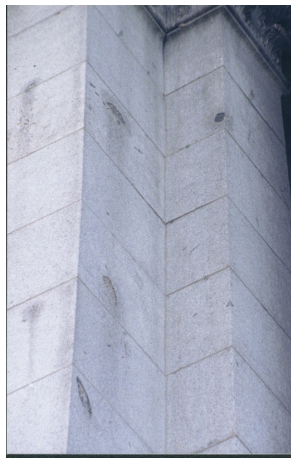
Code: EX-006**Description:** Pilaster shaft**Location:****Grid:** D/S 74**Condition:** CR, PATCracked element and poor quality
patching**Comments:**

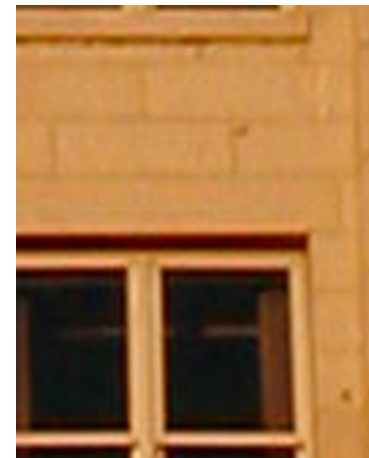
**Code:** EX-008**Description:** Wall stone**Location:****Grid:****Condition:** PAT

Poor quality, non-matching patch

Comments: small

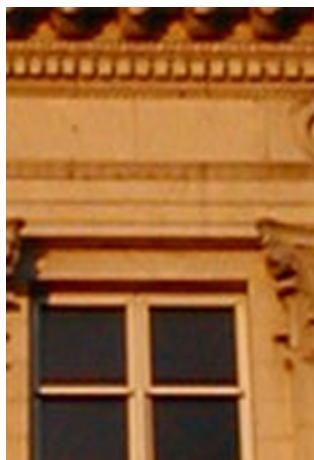
**Code:** EX-009**Description:** Entablature lower belt**Location:****Grid:** F/N 110**Condition:** CR

Cracked element

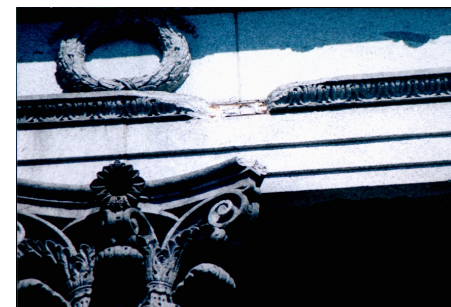
**Code:** EX-009**Description:** Entablature lower belt**Location:****Grid:** F/N 30, F/S 30; F/S 70**Condition:** BRBroken, severely cracked or
chipped**Comments:**

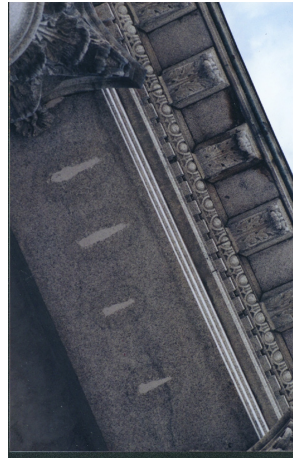
Code: EX-010**Description:** Entablature frieze**Location:****Grid:****Condition:** STSignificant Staining; may
indicate rusted connector**Comments:** underneath, typ

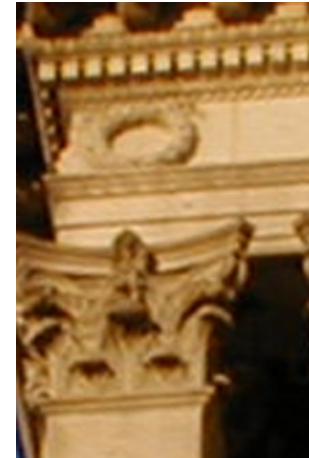
**Code:** EX-012**Description:** Entablature cornice**Location:****Grid:** G/N 80; G/N 69**Condition:** BRBroken, severely cracked or
chipped**Comments:** medallions

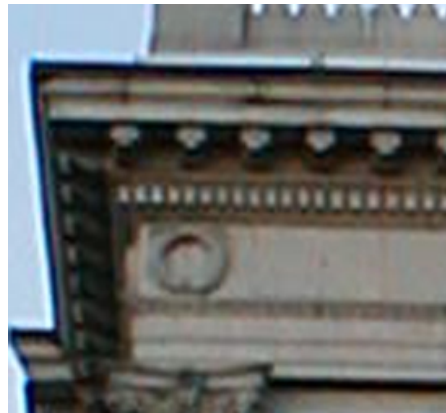
**Code:** EX-012**Description:** Entablature cornice**Location:****Grid:** G/N 120**Condition:** BRBroken, severely cracked or
chipped**Comments:** cornice

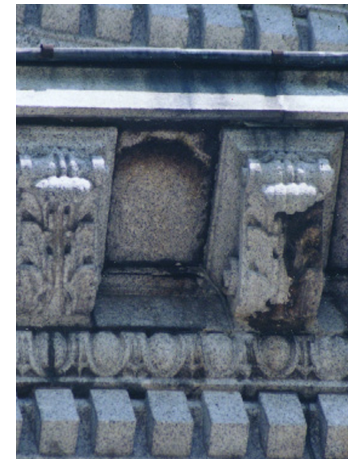
**Code:** EX-012**Description:** Entablature cornice**Location:****Grid:** G/S 25**Condition:** ST, CR

Significant staining and cracking

Comments: heavy rust colored stain

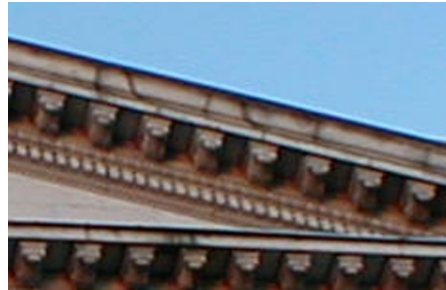
Code: EX-012**Description: Entablature cornice****Location:** at pediment**Grid:** H**Condition:** ST, CR

Significant staining and cracking

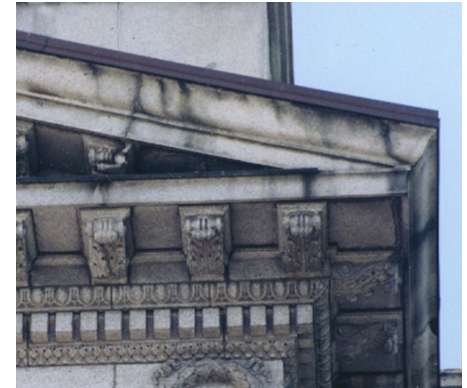
**Comments:** cracking, staining apparently from rusting flashing**Code: EX-014****Description: Pediment cornice****Location:****Grid:** G/S 70**Condition:** BR

Broken, severely cracked or chipped

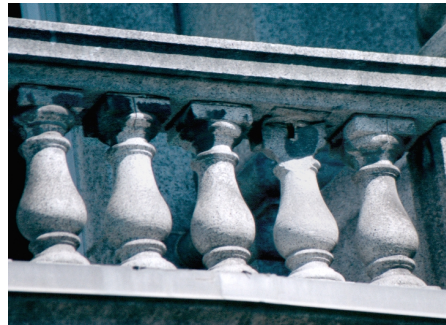
**Comments:****Code: EX-017****Description: Balustrade baluster****Location:****Grid:** H/N 80**Condition:** EX

Exfoliated or spalled surface

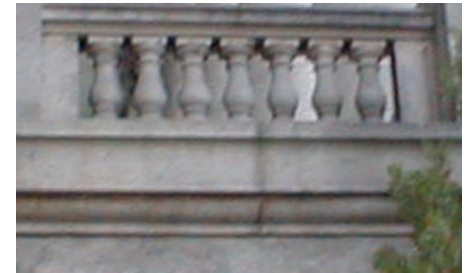
**Comments:****Code: EX-017****Description: Balustrade baluster****Location:****Grid:** C/S 76**Condition:** CR

Cracked element

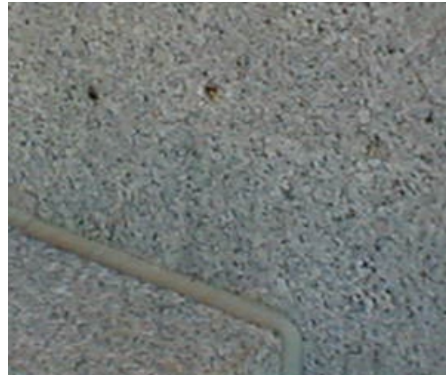
Description: Window

Grid: B/S 20

Condition: INT

Intrusive, non-original, non-essential element

Comments: metal anchors both sides

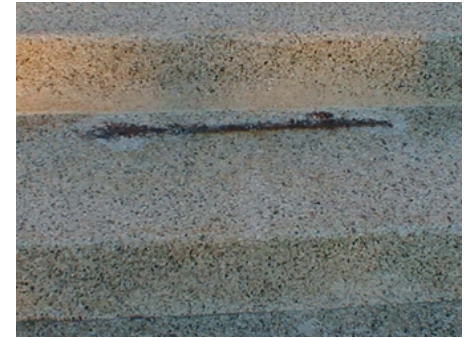
Description: Stairs

Grid: B/CL

Condition: BR

Broken, severely cracked or chipped

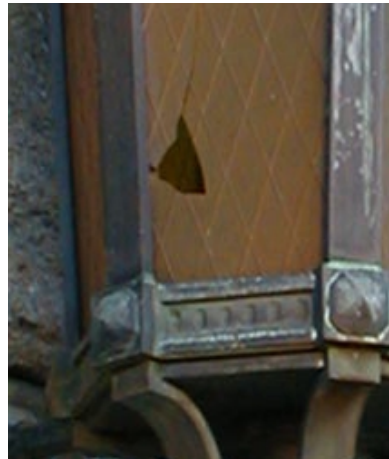
Description: Light

Grid: C/S 6.6

Condition: GL

Glass cracked, broken or non-matching

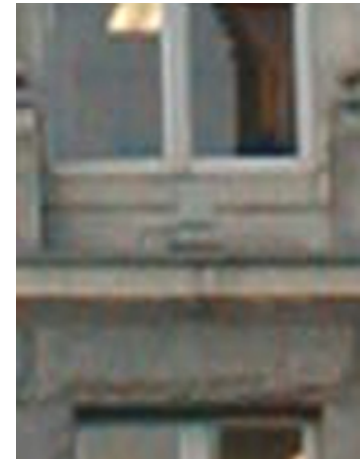
Description: Light

Condition: NO

Non-original, incompatible but essential elements

Comments: spot lights

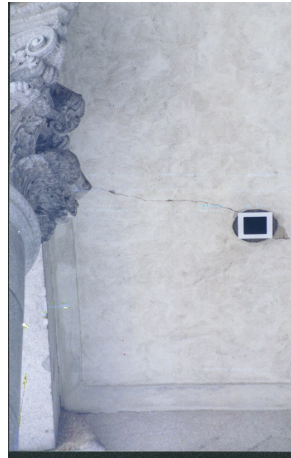
Description: Light

Condition: NO

Non-original, incompatible but essential elements

Comments: square lights over round hole

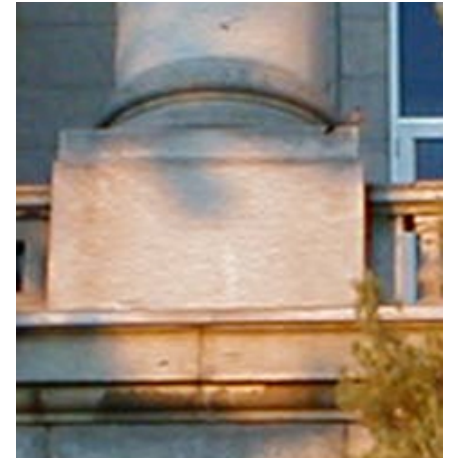
Description: Trim

Grid: C/N 69

Condition: EX

Exfoliated or spalled surface

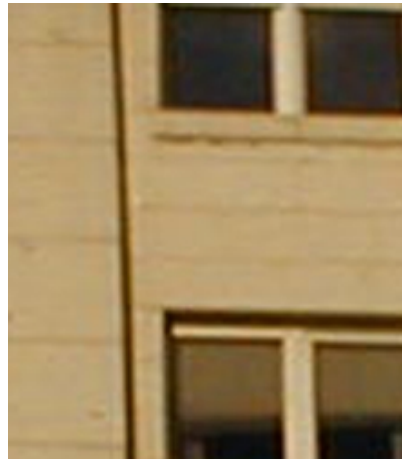
Description: Trim

Grid: E/N 102

Condition: CR

Cracked element

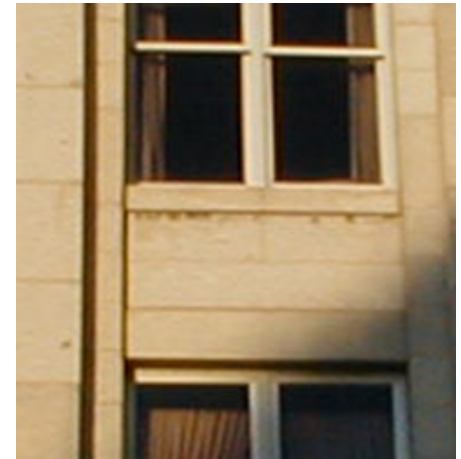
Description: Trim

Grid: E/N 102 & 90

Condition: BR

Broken, severely cracked or chipped

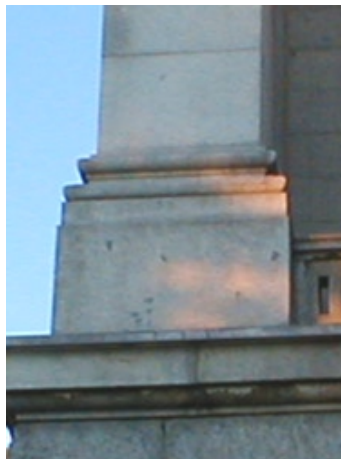
Code: EX-094**Description:** Trim*Location:**Grid:***Condition:** PAT

Poor quality, non-matching patch

Comments: typical; small

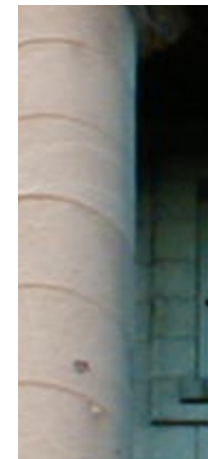
**Code:** EX-094**Description:** Trim*Location:**Grid:* F/E/N 74**Condition:** EX

Exfoliated or spalled surface

Comments: on S side of column

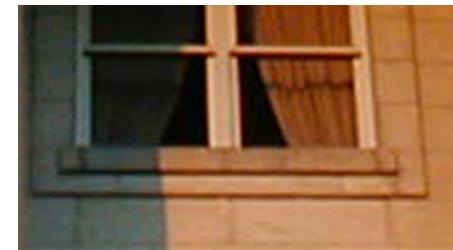
**Code:** EX-103**Description:** Window Sill*Location:**Grid:***Condition:** ST

Significant Staining; may indicate rusted connector

Comments: Window sill, 4th floor; TYP across West face, at sill edges, water draining insufficient.
